Sealing the deal

A genuine seal lowers the risk of damage and downtime

Case Story

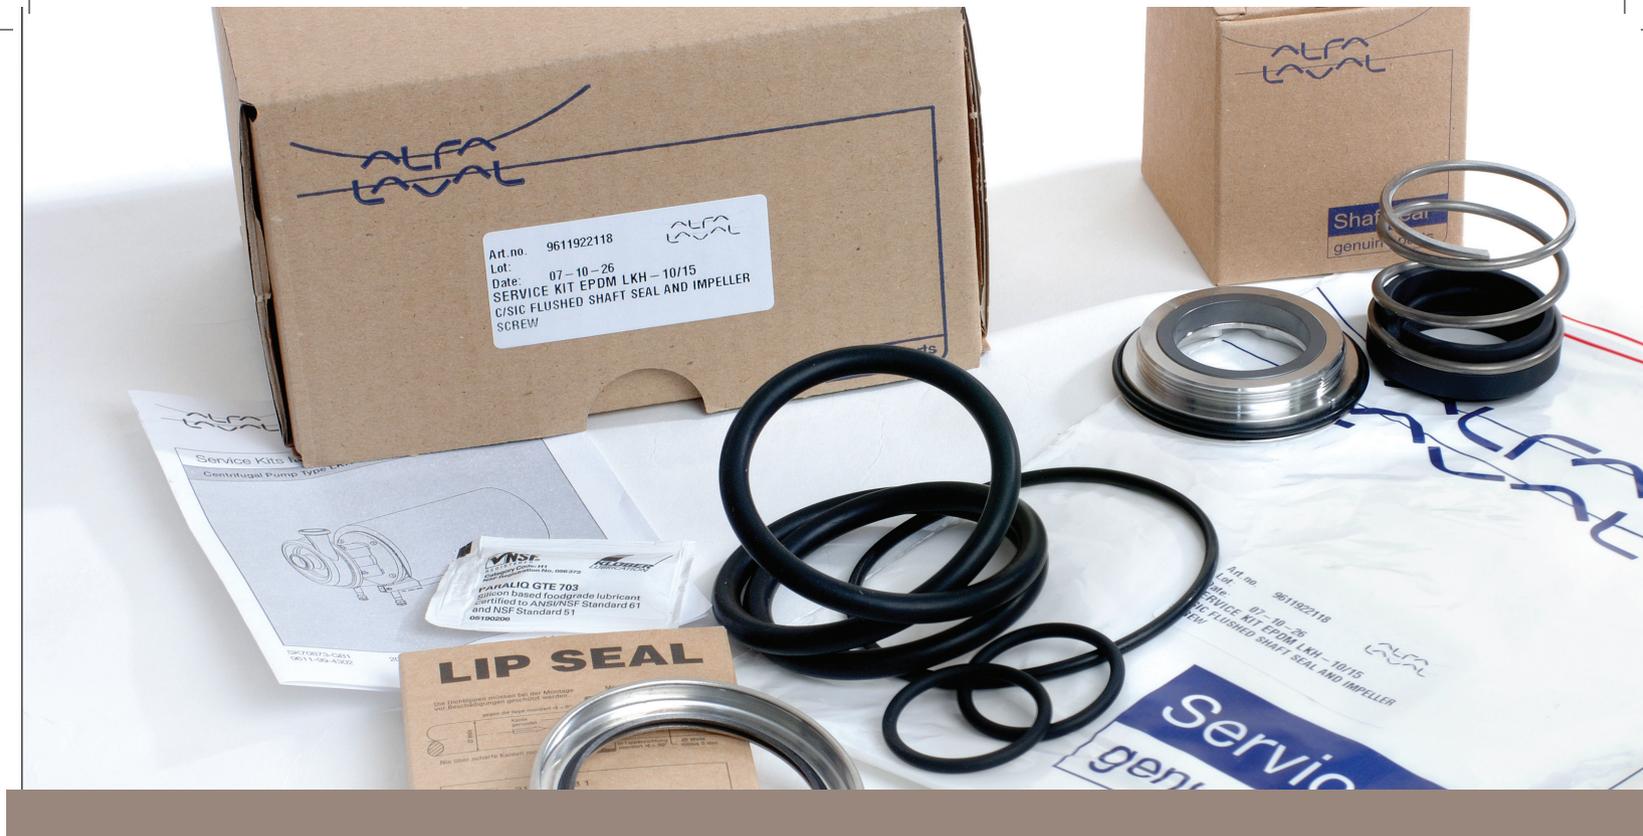
The main issue plaguing these various materials is that each is too similar to the material of the back plate, resulting in a high potential risk for seizure when being fitted.

In addition, the thermal expansion coefficient for the various materials is greater for than the duplex stainless steel currently used by Alfa Laval. Applied temperatures will create a greater change of flatness than the original material.

The first parameter examined was the static face holder. It was found that the alternate parts were machined in a variety of materials that deviate from the genuine Alfa Laval part. These included a variety of different materials, including AISI 316 stainless steel, which is two grades off from the genuine Alfa Laval part; AISI 304, which is one grade off from Alfa Laval; austenitic stainless steel: AISI 321, which is a titanium stabilized ANIS304; and a non-magnetic material indicating 316 steel or similar.
