Performance Audit optimizes the steam cracker of a global petrochemical company

Antwerp, Belgium

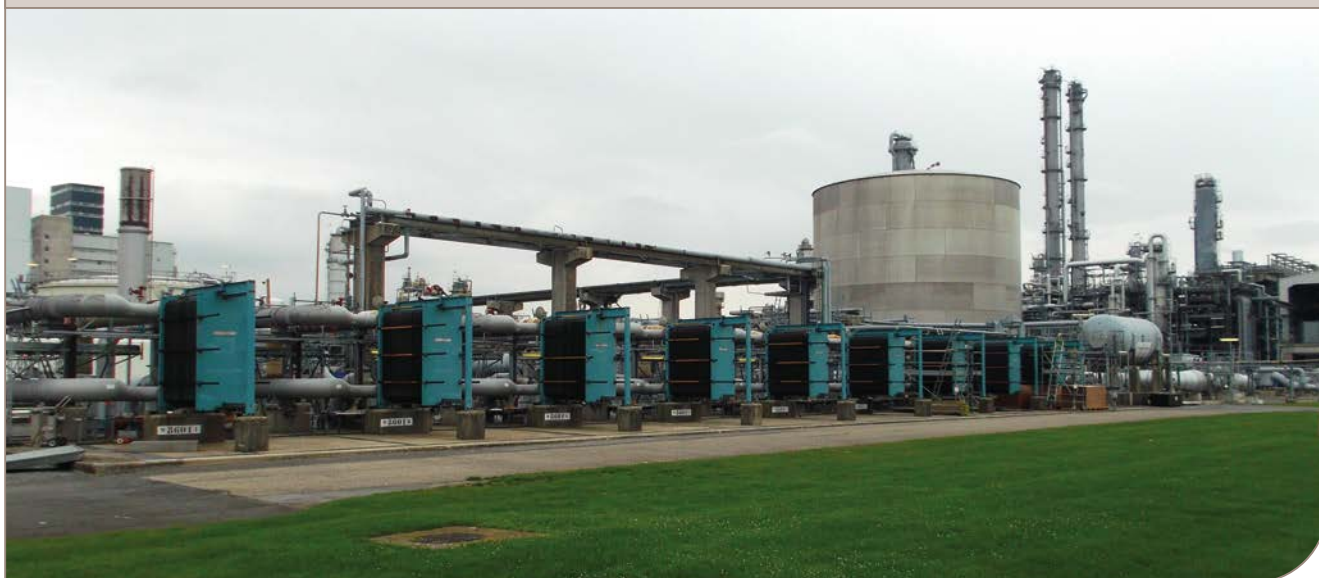
Nine Alfa Laval M30 units are responsible for cooling down the process water of the steam cracker.

“The gaskets were near the end of their lifetime. This could cause unplanned maintenance of the units. Therefore we concluded together to take this opportunity to perform a complete Alfa Laval Reconditioning Gasketed Plate Heat Exchanger in our Alfa Laval Service Centre in Waalwijk (NL). This included gaskets change, chemical cleaning of all plates and a plate integrity inspection. We then brought the plate number up to 493 for each heat exchanger and replaced low-theta plates with high-theta plates to improve the performance,” says Moolenaar.

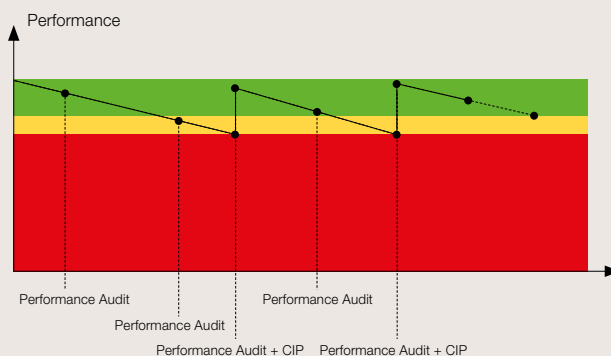
To monitor the performance of a plate heat exchanger, Alfa Laval needs to know the actual inlet and outlet temperatures for both fluids and the actual flow for one of them. Without disrupting operations, an authorized

Alfa Laval service engineer affixes four temperature gauges and one flow gauge to the outside of the heat exchanger pipes and collects data using a portable logger. The data is then analyzed with AlfaCheck software and a report is generated. Based on this report the customer can decide how and when to service the plate heat exchanger.
